# **HAZARDOUS MATERIALS TECHNICAL STUDY**

**1612 HILLSDALE ROAD  
SAN DIEGO COUNTY, CALIFORNIA**

**GEOCON PROJECT NO. 09674-06-01**

**APRIL 18, 2006**

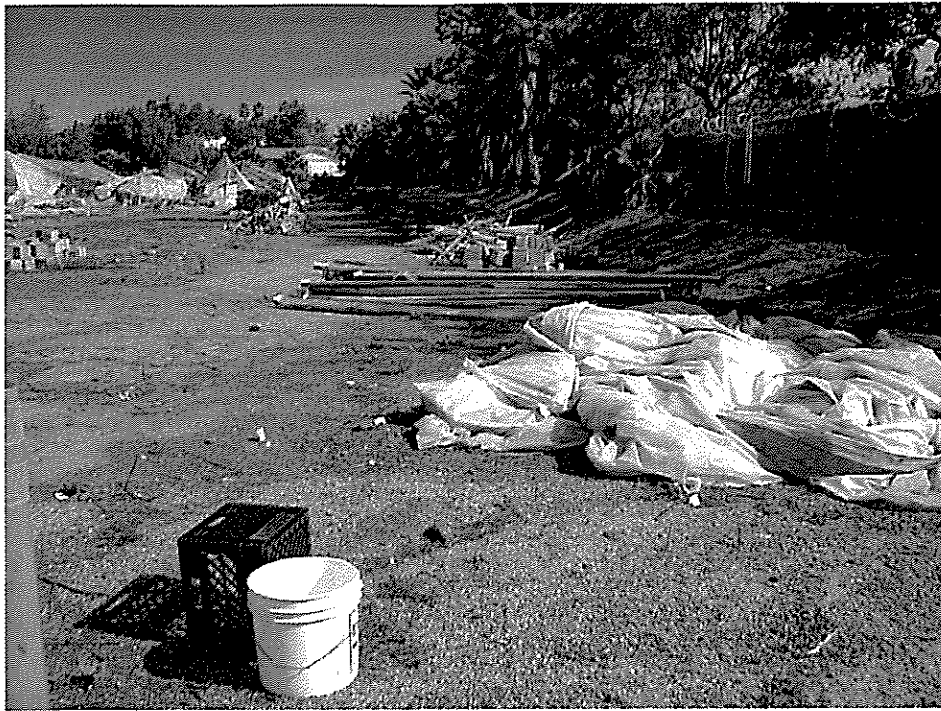
**Photograph #3**  
**Stockpiled materials located along the eastern property boundary of the Site.**

Areas of scattered trash/debris and abandoned equipment were observed throughout the Site. A metal roll-off bin and stockpiles of rubber tubing, pipes, plastic tar, concrete blocks, and wood and wire pallets were observed in the eastern portion of the Site. Geocon was unable to observe the interior of the bin. Additional stockpiles of concrete blocks and wood and wire pallets were located in the northwestern portion of the Site. Stockpiles of wood pallets were observed in the southern and southwestern portions of the Site. Geocon observed an abandoned truck and a cargo trailer in the southwestern portion of the Site and an additional abandoned truck in the southern portion. Based on signage observed on the side of the cargo trailer, it appeared that the trailer had been abandoned by East County Green Houses (a former occupant of the Site). Geocon observed materials within the trailer including wood and pipe fragments. Miscellaneous domestic litter was observed in the northeastern portion of the Site and along the drainage channel at the western property boundary. With the exception of the abandoned truck located in the southwestern portion of the Site (discussed above), no visual evidence of unauthorized disposal of hazardous waste or petroleum products (unusual odors or staining) was observed in the vicinity of the trash/debris and abandoned equipment observed onsite at the time of Geocon's site survey.

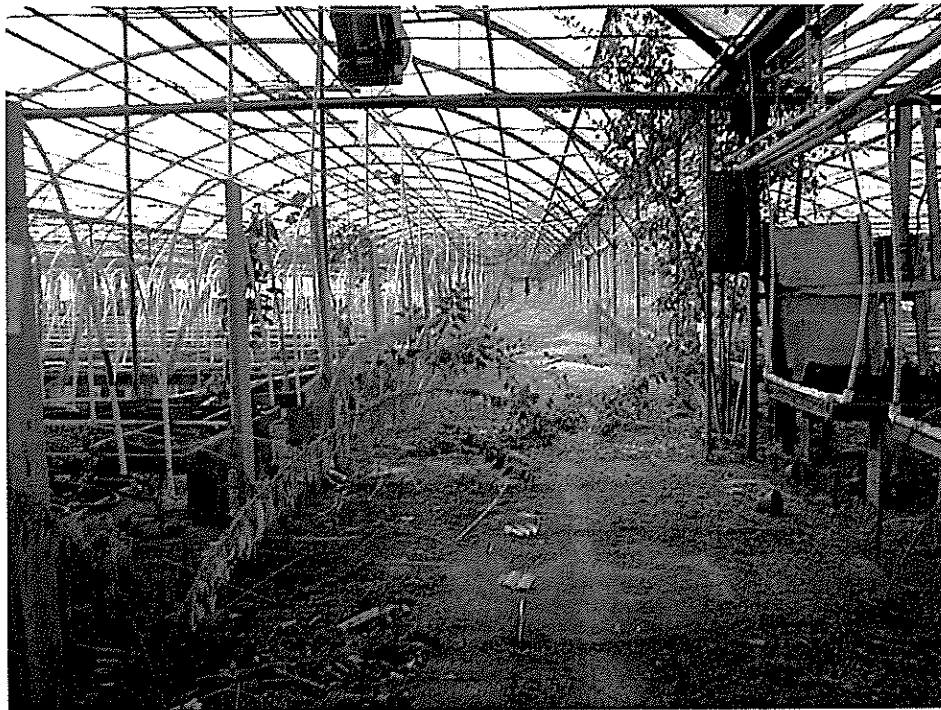
**Photograph #4**  
**Interior view of the main greenhouse located in the eastern portion of the Site.**  
**View is from the northern portion of the greenhouse, looking south.**

The nursery-related structures encompass approximately 3.5 acres of the Site. The eight onsite greenhouses are wood-frame structures with walls and roofs constructed of corrugated fiberglass. Five of the eight greenhouses were almost completely collapsed at the time of the site reconnaissance. The largest greenhouse (hereinafter referred to as the main greenhouse) is located in the eastern portion of the Site and was observed to be in superior condition compared to the smaller onsite greenhouses. The southernmost portion of the main greenhouse includes an approximately 6,800-square-foot concrete-paved room, which is currently being used as a temporary general storage/light construction/automotive equipment repair workshop by Mr. Brian Turner, the Client's Project Manager. Approximately 1,600 square feet of office space is located immediately east of the workshop. Geocon observed materials/equipment within the workshop, such as earth-moving equipment, paint products and other chemical containers (discussed in Section 2.1.1), vehicles in varying stages of repair, tires for large vehicles, and cabinets and other pieces of furniture. Restroom facilities are located in the western portion of the workshop. A concrete-paved ledge, which was presumably used by the former plant nursery as a truck loading dock, is located immediately west of the workshop. With the exception of the temporary workshop and office space located within the main greenhouse, the greenhouse floors are unpaved and covered with gravel or plastic tarp.

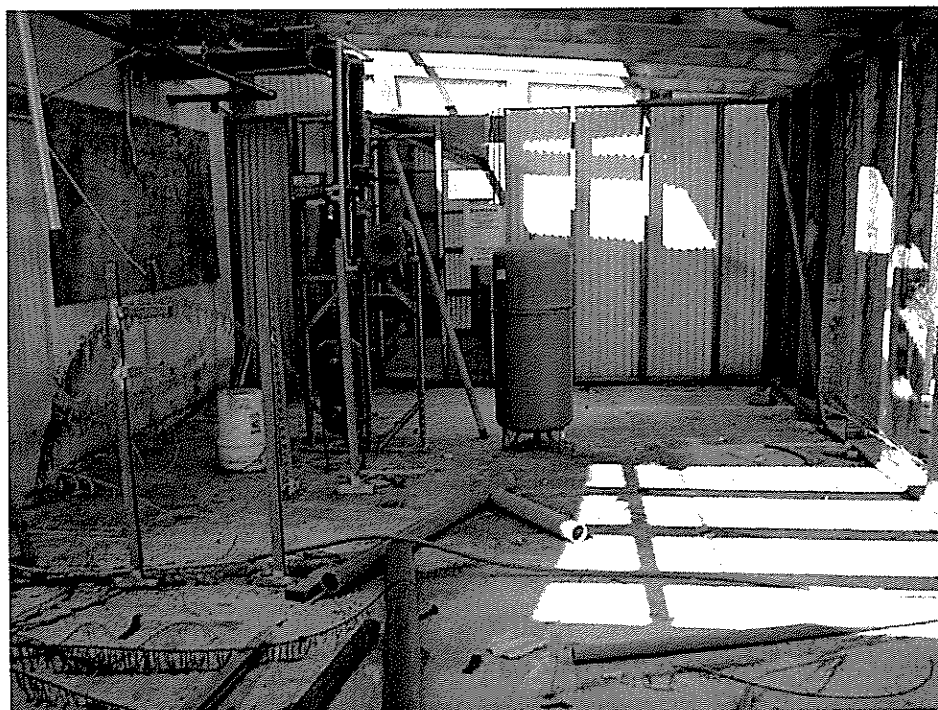
**Photograph #6**  
**Interior view of Shed A.**

Shed A is approximately 330 square feet in size and consists of two rooms separated by a fiberglass partition supported by wood beams. The larger of the two rooms occupies the central and eastern portions of the shed. Geocon observed equipment within this room, including an apparent water pressure boosting tank, bypass feeder for water, and associated piping leading into the northern portion of the main greenhouse. The equipment appeared to be associated with a heating system previously used by the plant nursery operation. With the exception of a few articles of abandoned furniture and equipment, the smaller of the two rooms in Shed A (occupying the western portion of the structure) was empty at the time of the site reconnaissance. Signage displayed on the entrance of this room indicated that the room previously had been used to store hazardous materials, such as pesticides, fertilizers, oil, and petroleum fuel. The concrete flooring of this room appeared to be in good condition with no visual evidence of spillage or leakage.

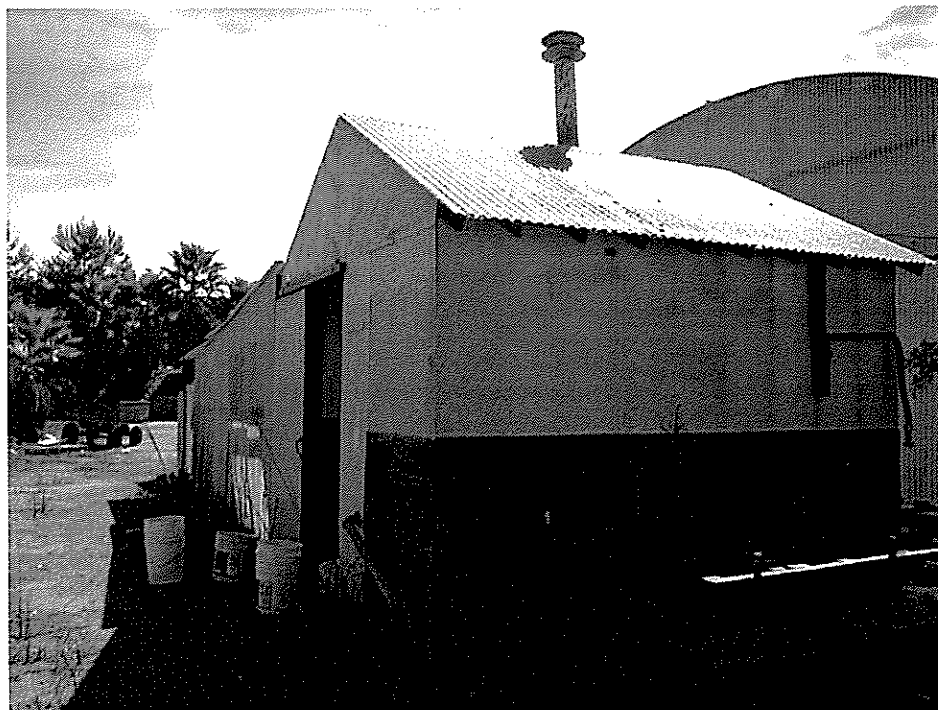
**Photograph #8**  
**Exterior view of Shed B.**

Shed B is approximately 360 square feet in size and is comprised of two rooms separated by a fiberglass partition supported by wood beams. The larger of the two room occupies the central and eastern portions of the shed and, as previously discussed, has a floor apparently consisting of overlapping wood boards. Abandoned equipment, such as pieces of pipe, large metal fans, corrugated fiberglass sheeting, a five-gallon plastic bucket that appeared to contain motor oil (further discussed in Section 2.1.1), and empty five-gallon plastic buckets, was observed within this portion of the shed. Geocon observed several pieces of equipment associated with a steam boiler and empty five-gallon plastic buckets within the room located on the west side of Shed B. The steam boiler was also presumably related to a former heating system of the plant nursery.

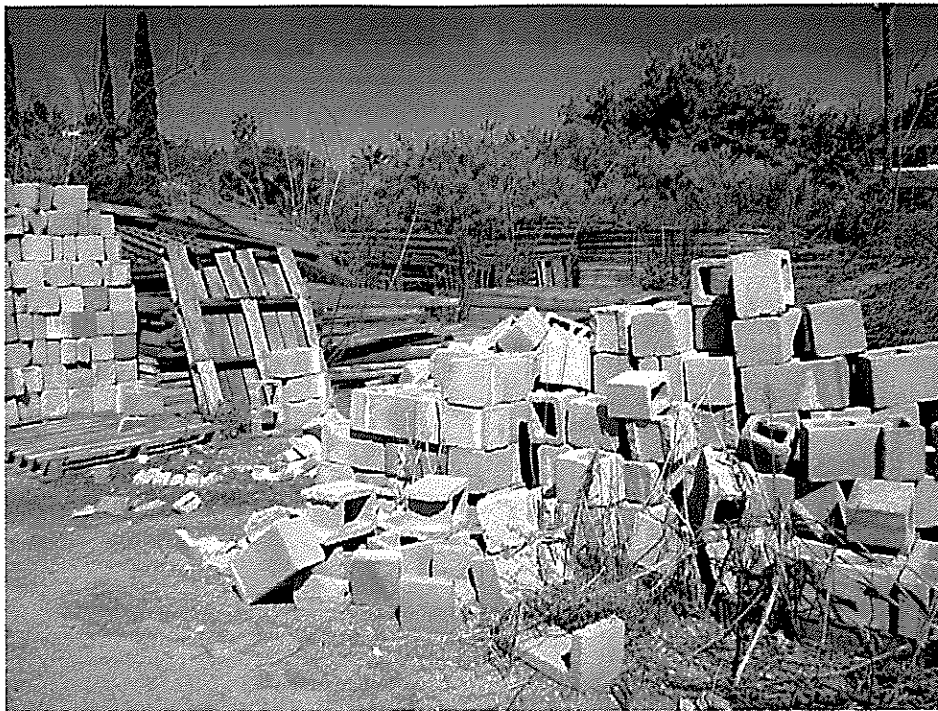
**Photograph #11**

**Stockpiled concrete blocks and wood pallets located in the northwestern portion of the Site.**

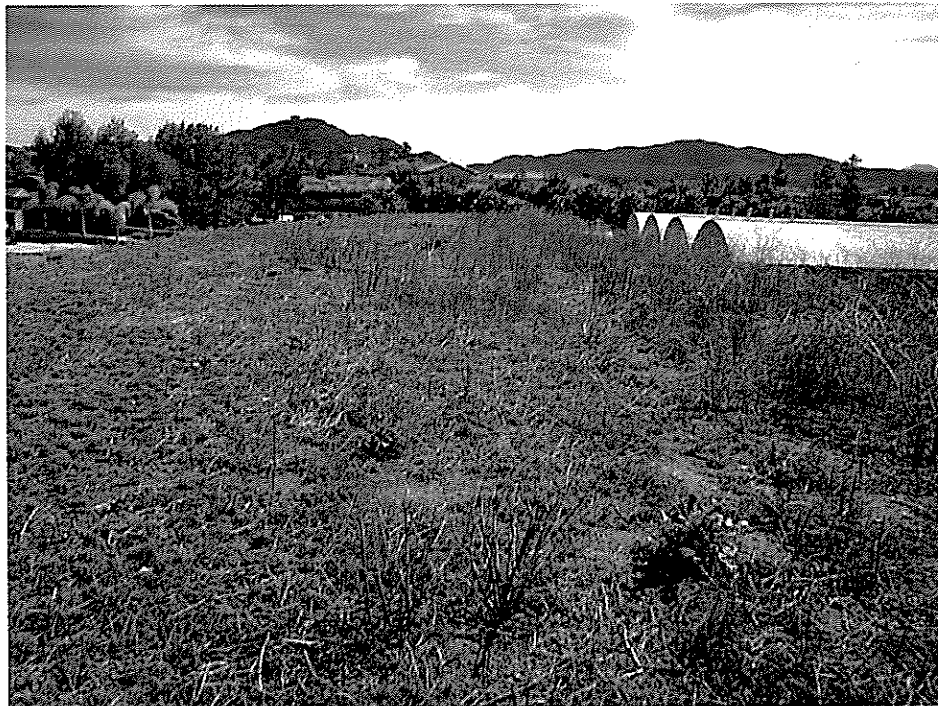
**Photograph #12**

**Undeveloped plateau located in the northern portion of the Site.  
View is from the northwestern portion of the Site, looking east.**

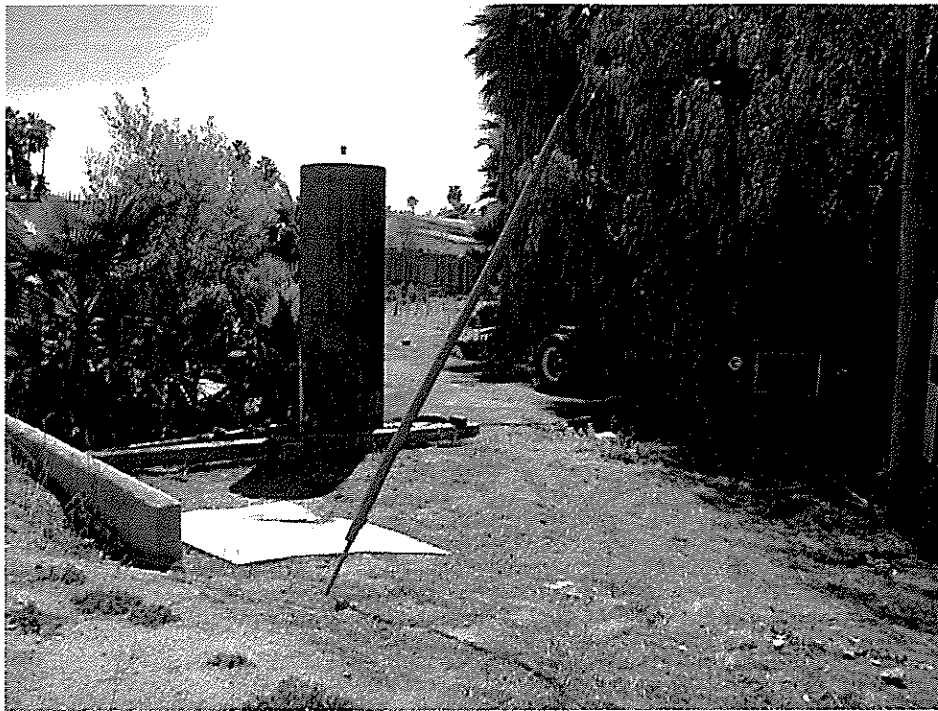
**Photograph #13**  
Abandoned equipment located in the southwestern portion of the Site.

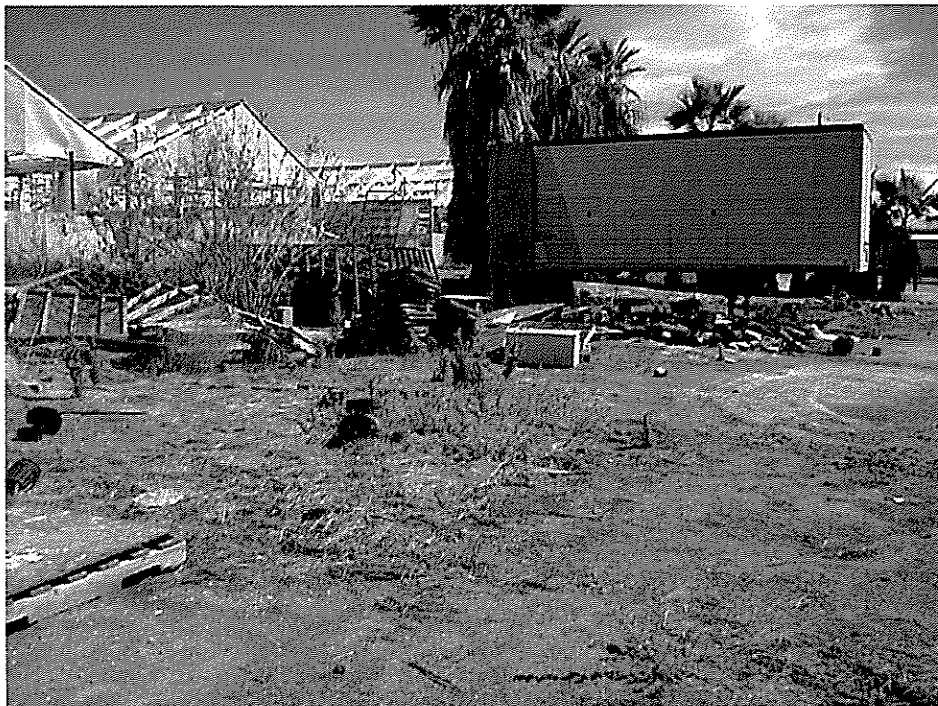
**Photograph #14**  
Trash/debris and abandoned cargo trailer located in the southwestern portion of the Site.

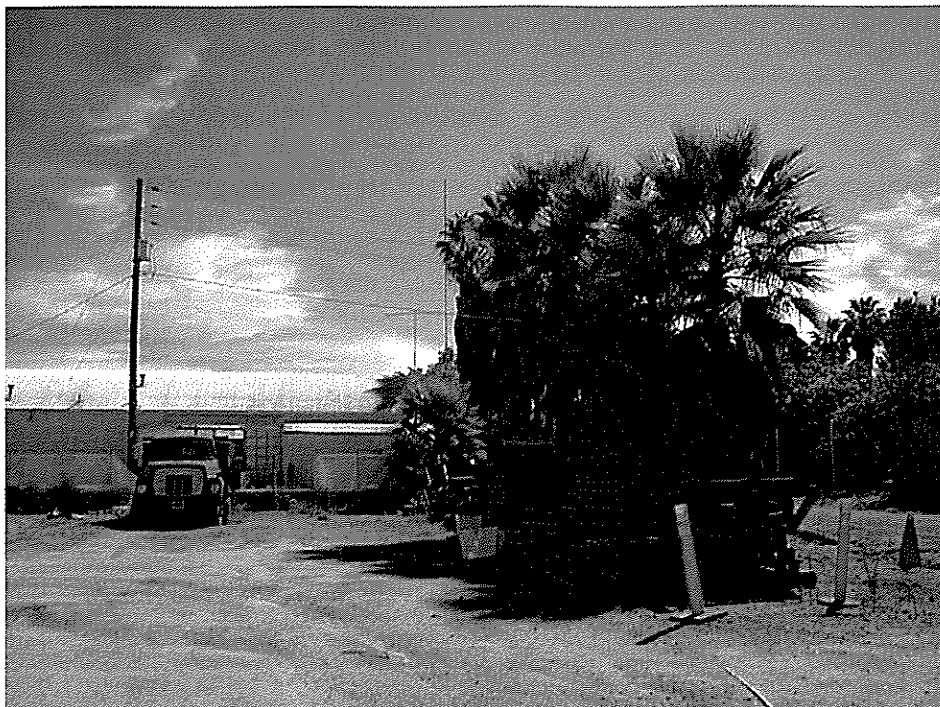
**Photograph #15**  
Abandoned truck, stockpiled wood pallets, and pole-mounted electrical transformer located in the southern portion of the Site.

Two pole-mounted electrical transformers, owned and maintained by San Diego Gas & Electric Company (SDG&E), were observed on an electrical pole in the southern portion of the Site. The

transformers were attached to north-to-south trending overhead electrical lines traversing the southern portion of the property. The transformers appeared to be in good condition, with no visual evidence of spills or leaks. See Section 5.3 for information regarding the polychlorinated biphenyl (PCB) content of the transformers.

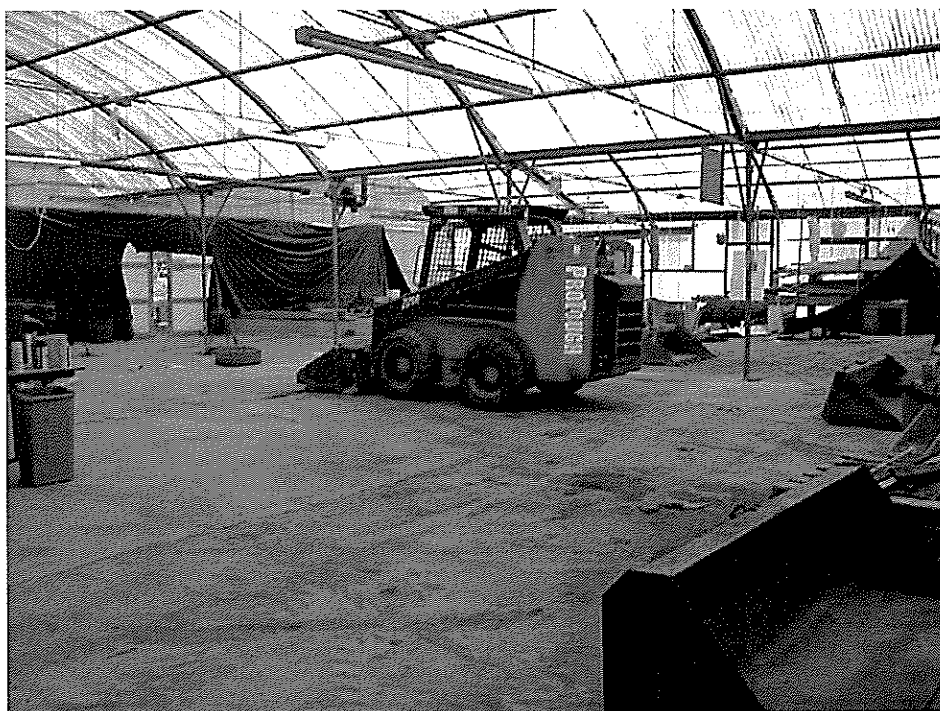
**Photograph #16**  
Temporary workshop located in the southernmost portion of the main greenhouse.

Paint, wood protector, and other paint products.	Several 32-ounce, 1-gallon, and 5-gallon plastic and metal containers.	Stored on the concrete floor and wood shelves within the temporary workshop of the main greenhouse.	No	N
Battery acid.	Three automotive batteries.	One battery was observed on top of a wood and wire pallet located within the main greenhouse, one battery was observed on the gravel-covered, unpaved private parking area immediately northeast of the residence, and one battery was observed on top of a lumber stockpile located adjacent to the private garage of the residence.	No	N

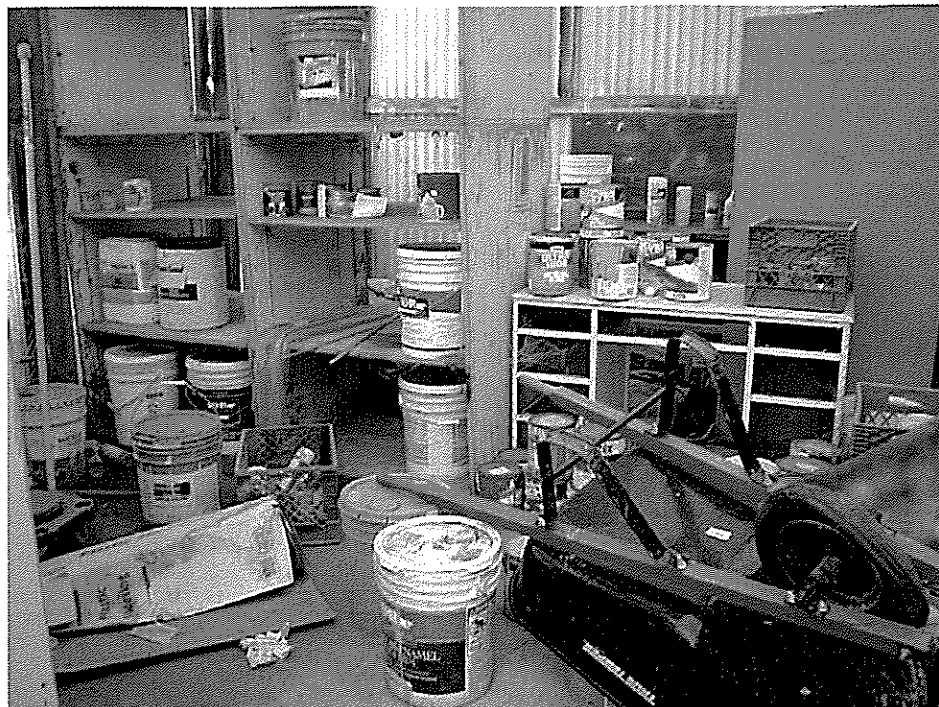
**Photograph #17**  
**Paint products located in the southern portion of the workshop.**

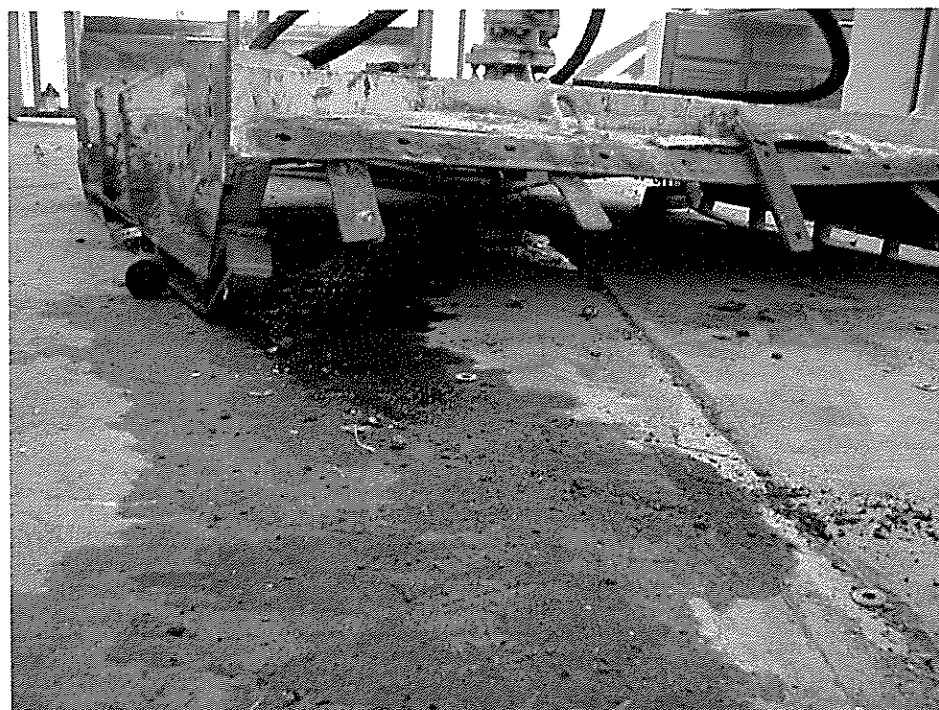
**Photograph #18**  
**Oily stain located in the northeastern portion of the workshop.**

In addition to the *de minimis* areas of staining (i.e., amounts not presenting a material risk of harm to public health or the environment) previously discussed, areas of stained concrete flooring were observed in the temporary workshop of the main greenhouse, as well as on the concrete-paved driveway located adjacent to the onsite private garage. The stained areas appeared to be the result of leaks in the hazardous substance storage containers and/or equipment stored in those portions of the Site. The concrete in the areas of the observed staining appeared to be in good condition with no evidence of cracks or deterioration.

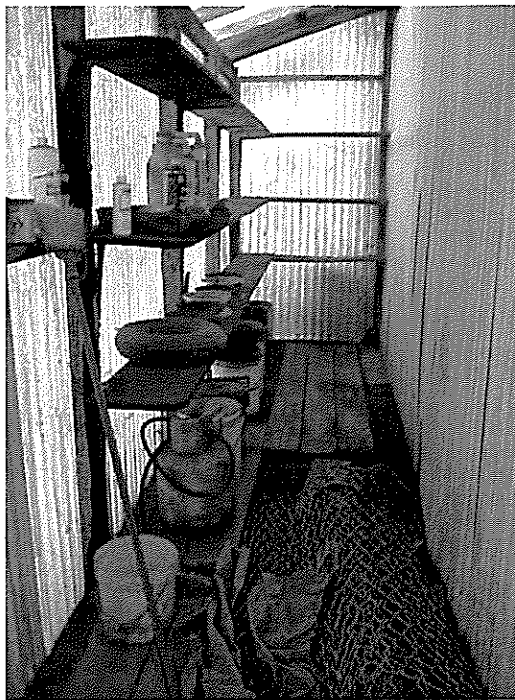
**Photograph #19**  
**Interior view of Shed C.**

Shed C is approximately 40 square feet in size and contains wall-mounted wood shelving stocked with hazardous materials reportedly used by the former onsite plant nursery (further discussed in Sections 2.1.1 and 2.1.4). Other materials observed within the shed included rolled chain-link fencing and plastic sheeting. Wood boards were laid across the northern and western portions of the concrete floor of the shed.

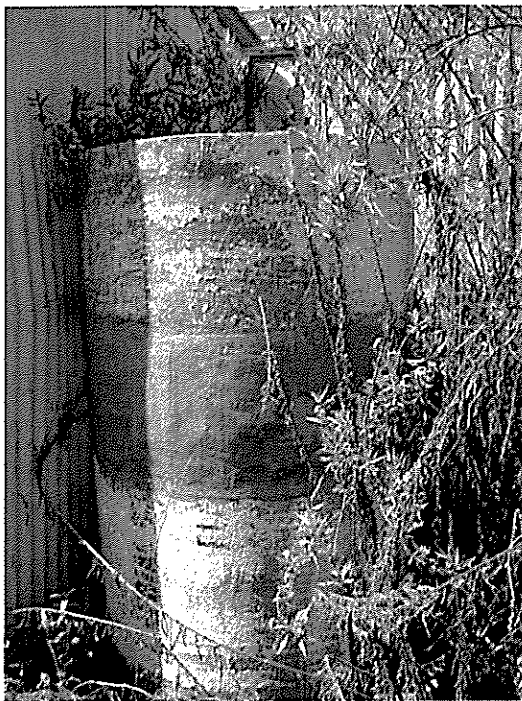
**Photograph #21**  
**Apparent abandoned fertilizer/pesticide aboveground storage tank located in the southern portion of the Site.**

Onsite ASTs						
Capacity	Contents	Storage Location	Use	Type of Leak/Spill Protection	Stains/Leaks Observed	REC (Y/N)
200 Gallons	Water	Stored on the ground surface in the southwestern portion of the Site.	Believed to have been used by the former plant nursery operation to irrigate the onsite flora.	Unknown	No	N
Approx. 75 Gallons	Fertilizer or Pesticides (assumed)	Stored on a wood pallet immediately north of Shed D.	Reportedly, currently or previously contained pesticides or fertilizer which was used on the plants grown at the nursery (according to Mr. Turner).	Unknown	No	N

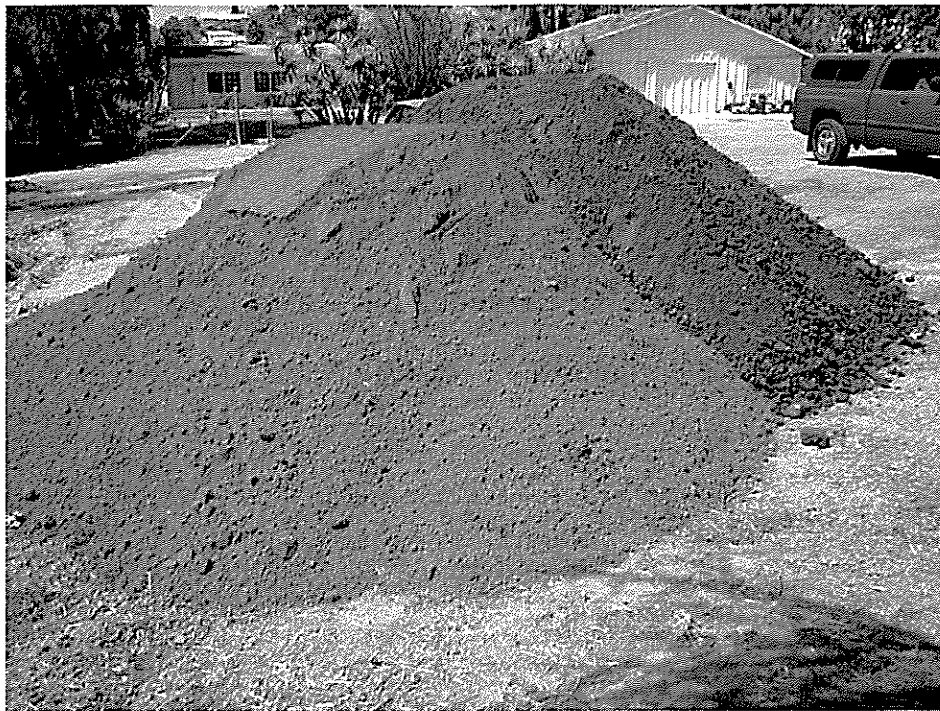
**Photograph #25**

**Soil and asphalt stockpile located in the southeastern portion of the Site.**

An area of stockpiled soil containing small fragments of asphalt was observed in the southeastern portion of the Site. Mr. Turner explained that the soil is used as base material for offsite driveway paving projects. Mr. Turner indicated that the material may also be used as filler material for the onsite unpaved driveway (southeastern portion of the Site) as the driveway begins to wear. Mr. Turner was unaware of where the soil had originated from. Geocon did not observe chemical containers or visual evidence of unauthorized disposal of hazardous materials/wastes (unusual odors or staining) in the soil stockpile.
